Hydrogeological Assessment Study for the proposed construction and maintenance of New System 1 at Rand Water Vereeniging Treatment Works, installation of approximately 7 km phase 2 Sludge Pipeline in Vereeniging, 1.5 km sludge line in Panfontein and associated infrastructure within the jurisdiction of Sedibeng District Municipality, Gauteng Province.

HYDROGEOLOGICAL INVESTIGATION STUDY FOR THE PROPOSED CONSTRUCTION AND MAINTENANCE OF NEW SYSTEM 1 AT RAND WATER VEREENIGING TREATMENT WORKS, INSTALLATION OF APPROXIMATELY 7 KM PHASE 2 SLUDGE PIPELINE IN VEREENIGING AND ASSOCIATED INFRASTRUCTURE WITHIN THE JURISDICTION OF SEDIBENG DISTRICT MUNICIPALITY, GAUTENG PROVINCE.

TITLE: HYDROGEOLOGICAL STUDY FOR THE NEW SYSTEM IN VEREENIGING AND INSTALLATION OF SLUDGE PIPELINES FOR PHASE 2

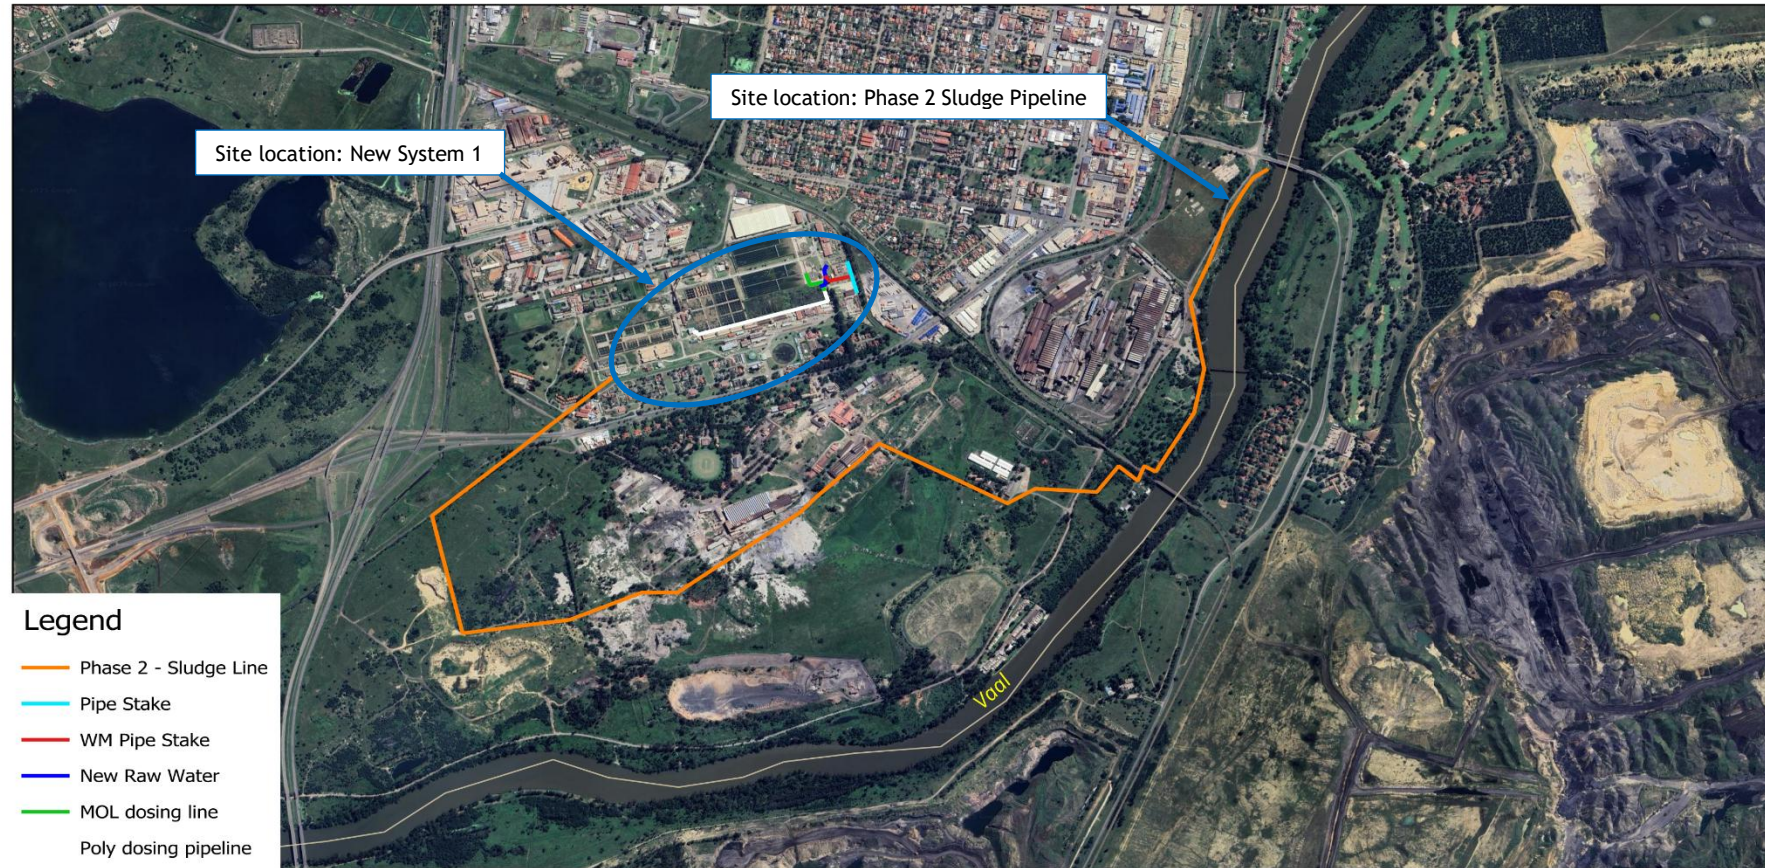
FIGURE 4-2 GEOLOGY MAP

According to the published 1:500,000 Hydrogeological Map Series 2526 Johannesburg (Barnard, 2000), the Vryheid Formation quality is mostly acceptable for any use and yield potential is considered to be low. This is based on approximately 83 % of the boreholes on record produce less than 2 L/s. Groundwater rest levels is generally encountered between 2 and 25 m below ground level (m bgl).

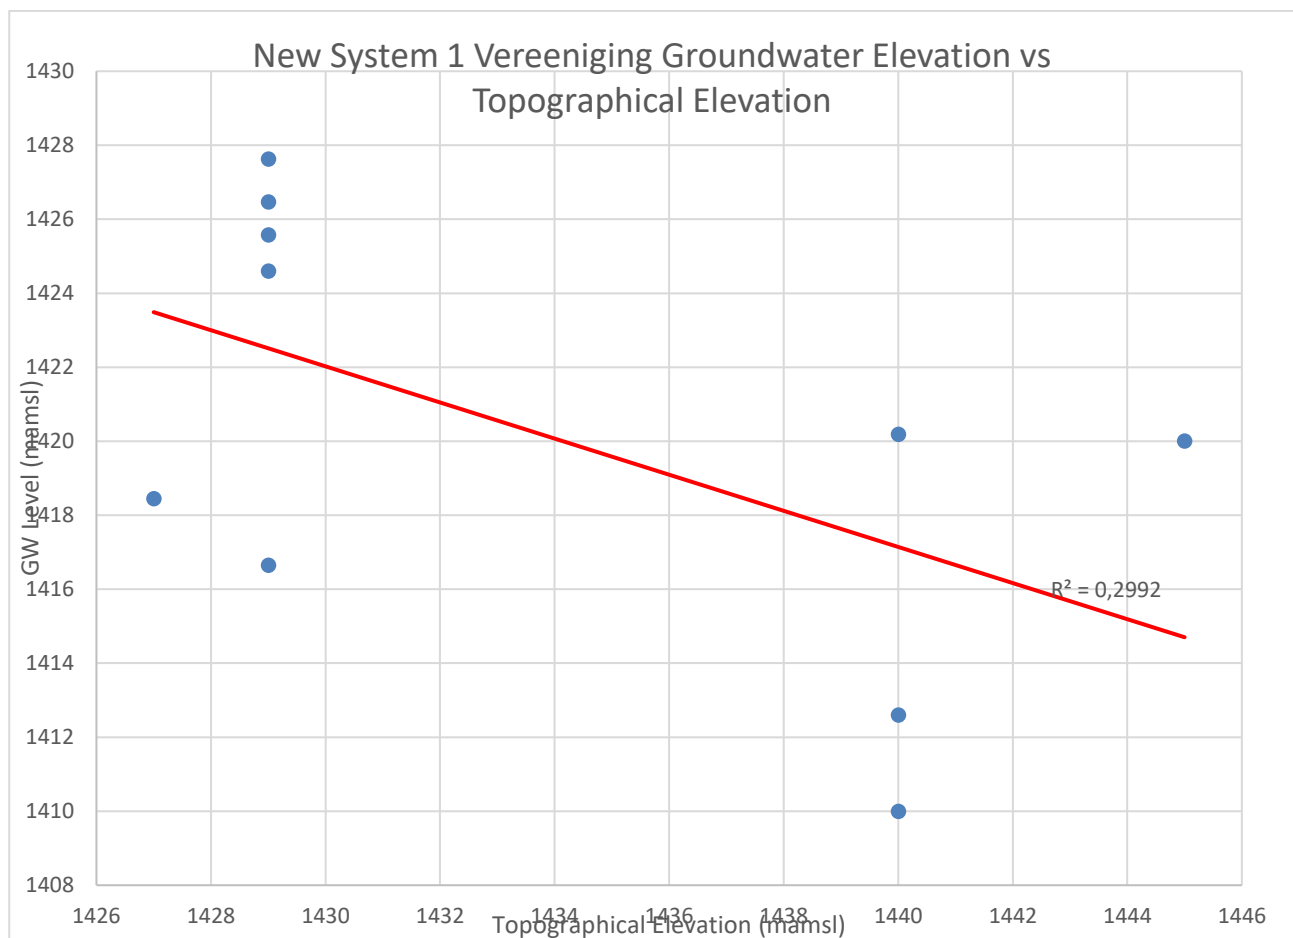
FIGURE 6-2: GW VS TOPOGRAPHICAL ELEVATION

A good correlation between the measured head and topography can be seen in Figure 6-2 ($R^2 = 0.2992$, i.e., approximately 99% of observed groundwater level variations can be explained by variations in land surface elevation and it can be assumed that the water table slightly mimics the surface topography but is somewhat higher or somewhat lower in places.

Groundwater elevation and Flow Regime based on groundwater level measurements obtained from NGA data was used to create groundwater flow directions. In general, the water table mimics the topography, and groundwater flow is from areas of higher lying ground.

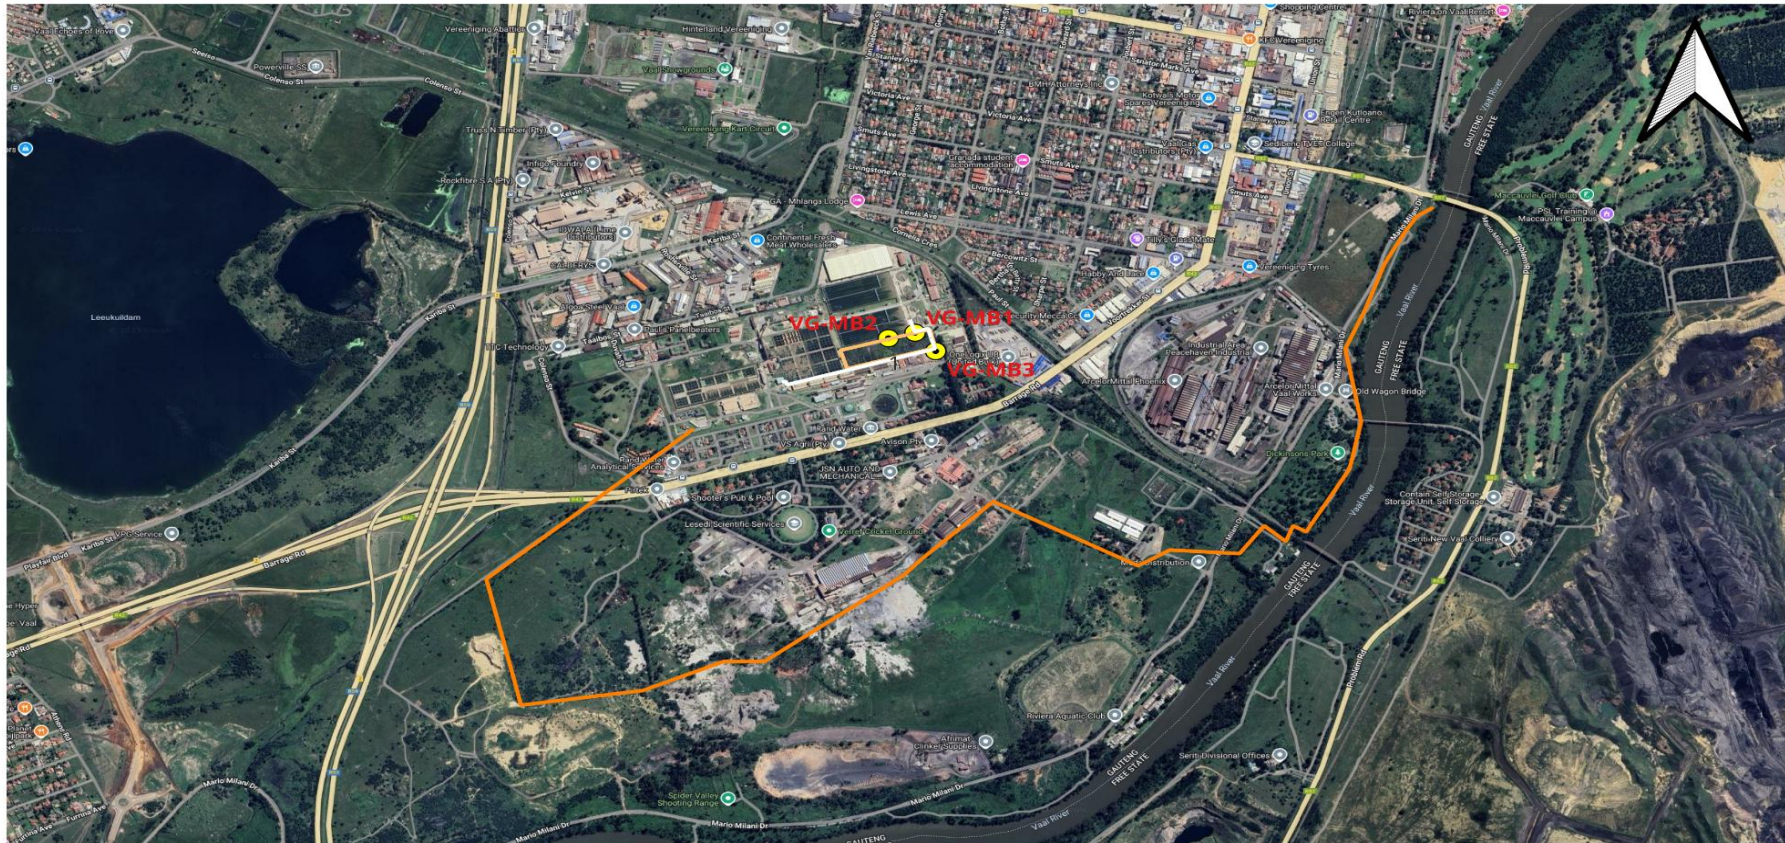
FIGURE 7-1 HYDROCENSUS MAP

Legend New System 1 VG System 1 — waypoints Sludge line	0 1 2 3 4 5 6 7 8 9 km 	Date Compiled: 25/06/2025	
		Coordinates System and Projection: WGS 84

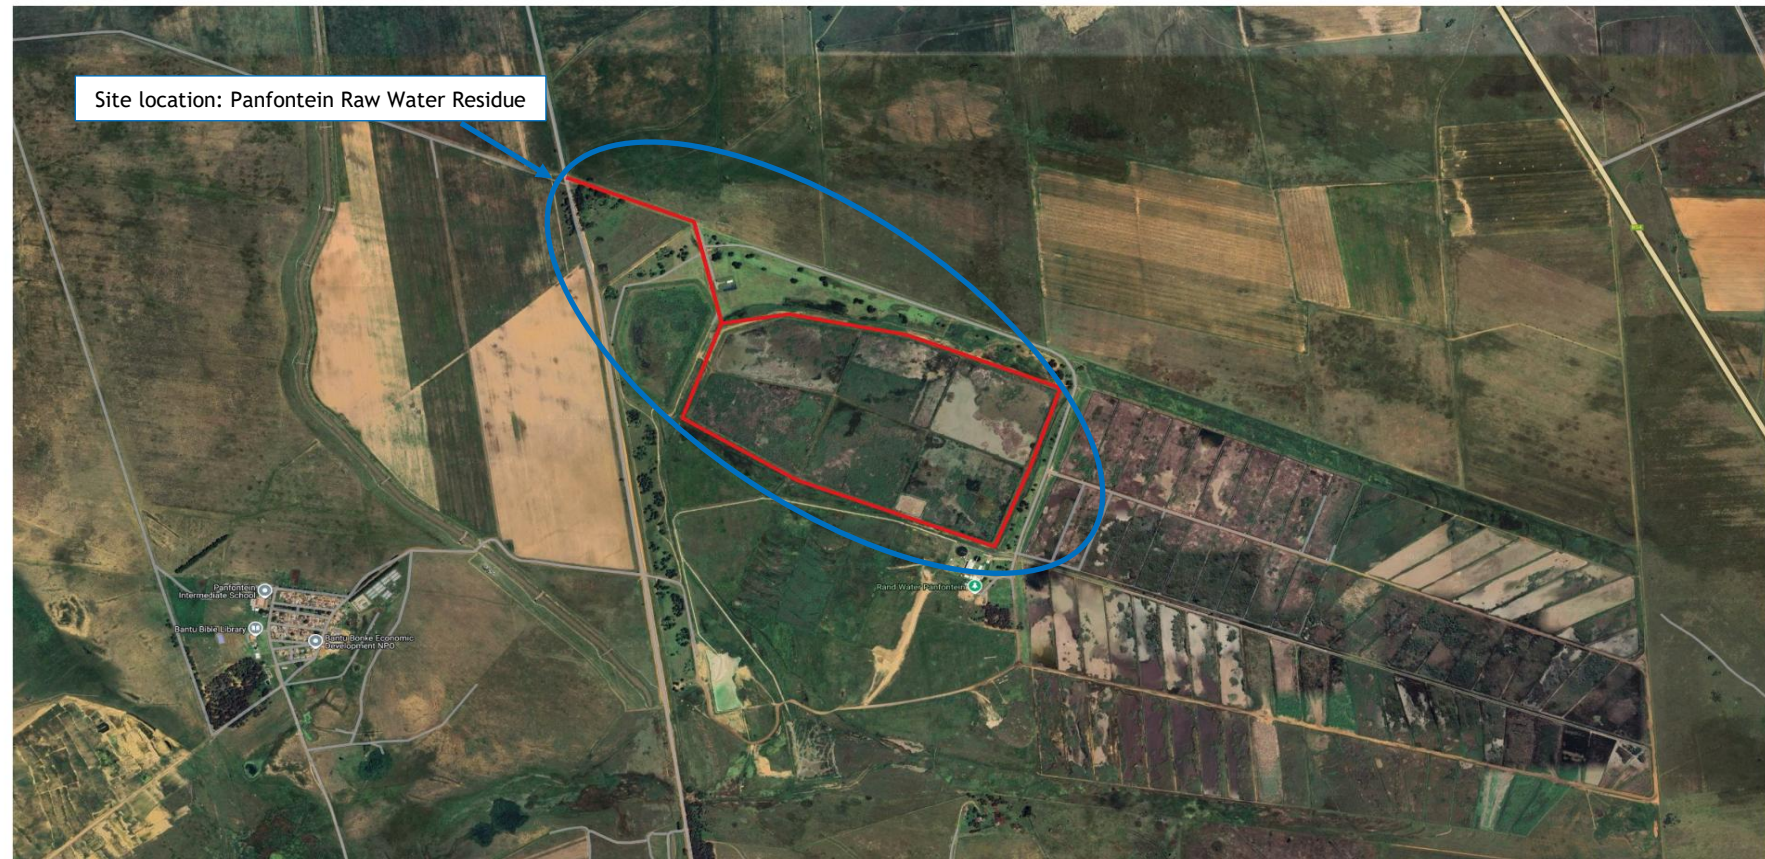
FIGURE 4-2 GEOLOGY MAP

The geological strata beneath the Panfontein site are partially weathered for the first few meters below surface. The weathered zone allows for somewhat higher recharge and primary porosity and permeability. Figure 4-2. The site is underlain by aeolian sand in places.

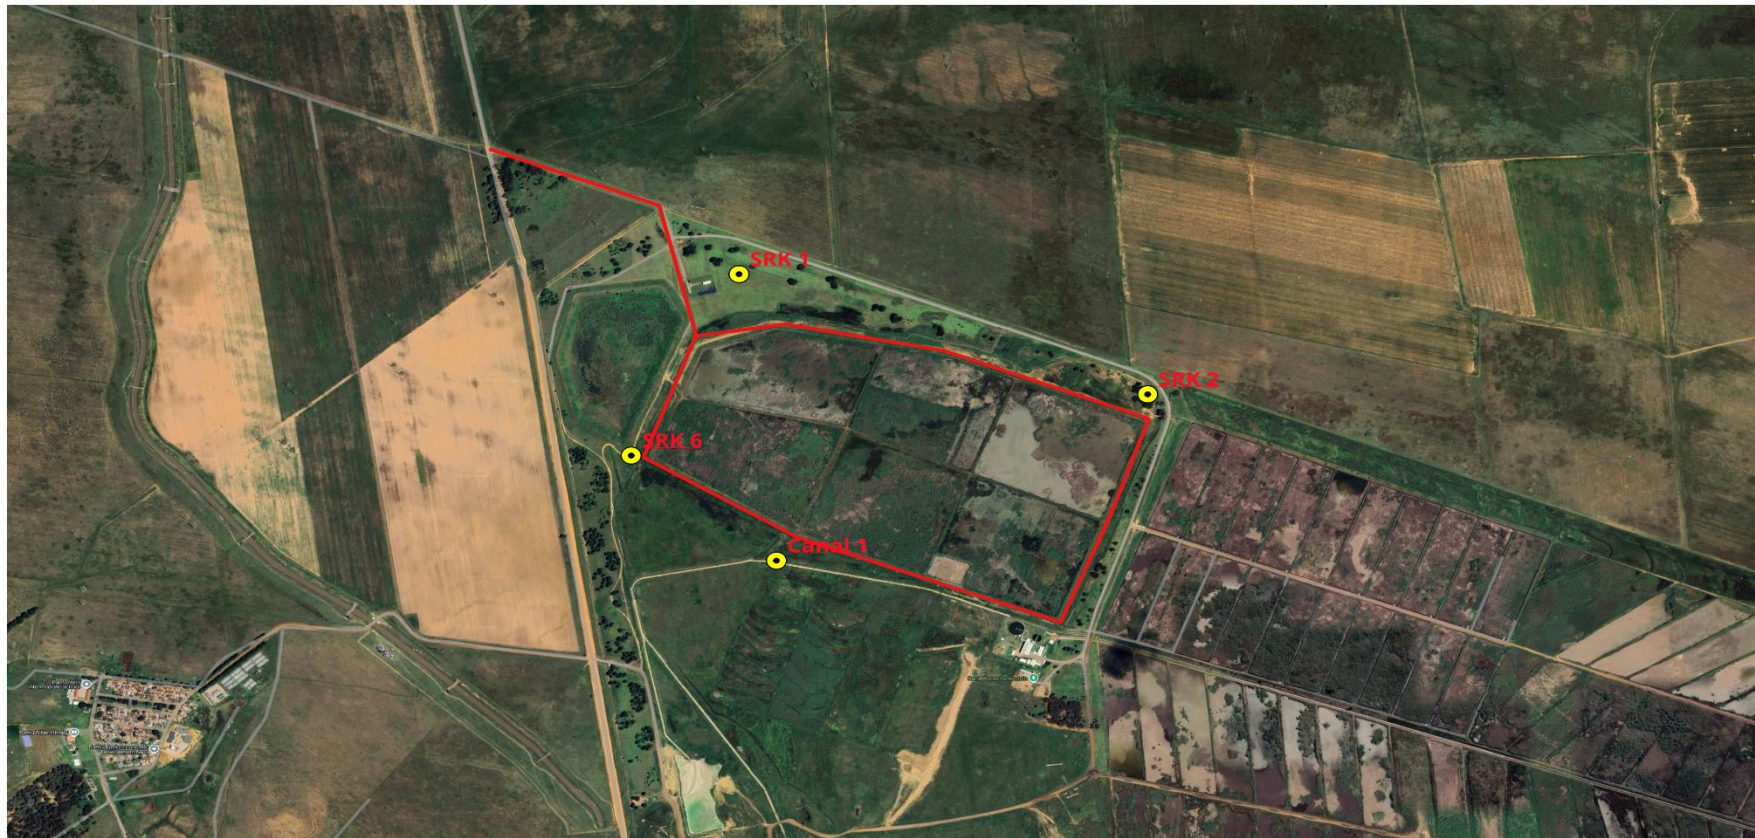
FIGURE 7-1 HYDROCENSUS MAP

Ariys Consulting undertook the hydrocensus investigation on the 26th of May 2025. A total number of three (3) boreholes and one (1) stream were identified during the hydrocensus investigation. Details of the boreholes and stream are presented in Table 7-1, Table 7-2 and Figure 7-1.
