Geotechnical Assessment Study for the proposed construction and maintenance of New System 1 at Rand Water Vereeniging Treatment Works, installation of approximately 7 km phase 2 Sludge Pipeline in Vereeniging, 1.5 km sludge line in Panfontein and associated infrastructure within the jurisdiction of Sedibeng District Municipality, Gauteng Province

GEOTECHNICAL INVESTIGATION REPORT ON THE B19 SLUDGE PIPELINE PHASE 2 ZUIKERBOSCH-VEREENIGING

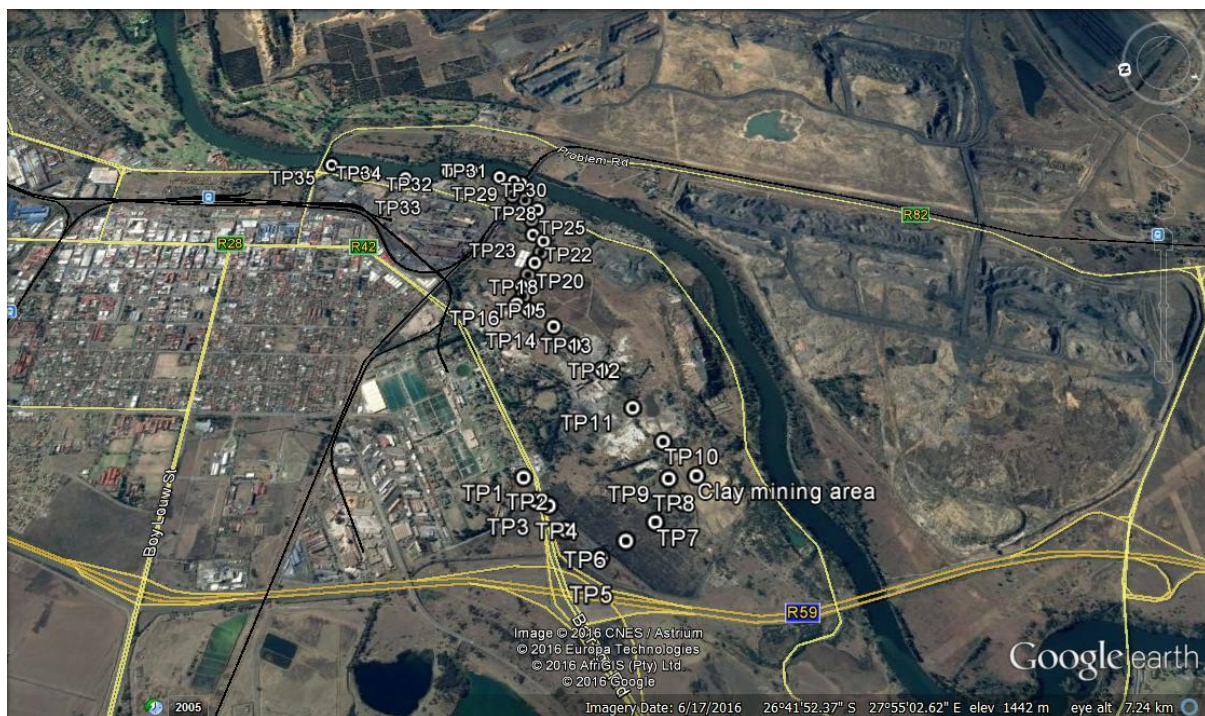
Figure 2: Google Earth B19 Sludge Pipeline

The site is located in Vereeniging, the Central Business District of Vereeniging which is situated south east of Johannesburg and accessible along R59 Dual Carriage Way that connects Vaal and Johannesburg. In Vereeniging, the B19 Sludge Pipeline route is accessible along the intersection of R42 Voortrekker Street/Barrage Road and R82 Victoria Avenue. The B19 Sludge Pipeline route is presented by test pit locations (marked as TP) along the route in the Google Earth Image, Figure 2 below.

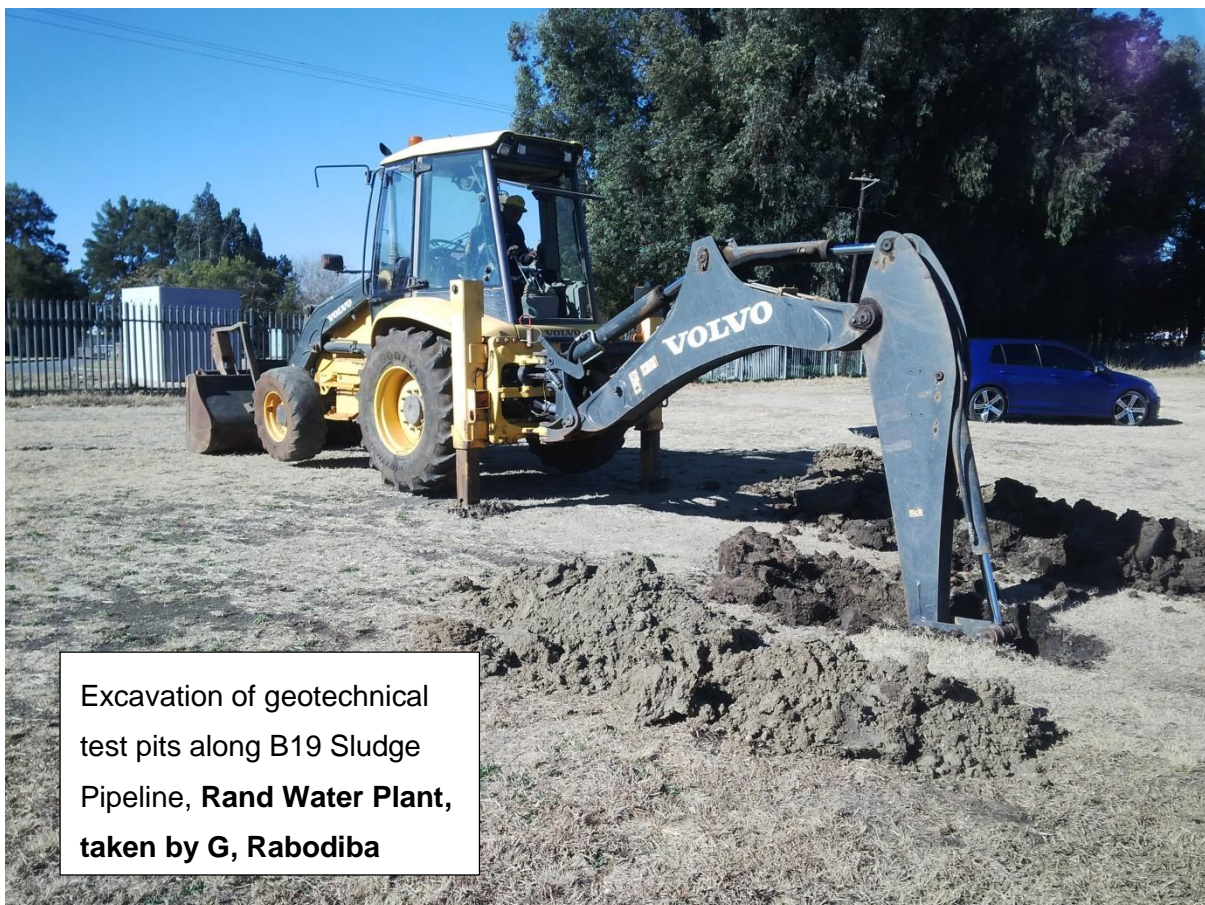
Tractor Loader Backhoe, manufactured by VOLVO was used for excavation of the test pits. The test pits were excavated to the reach of the TLB and logged by an experienced engineering geologist.

Picture taken at Rand Water Treatment Works, Test Pit number 1, Chainage 0.0m.

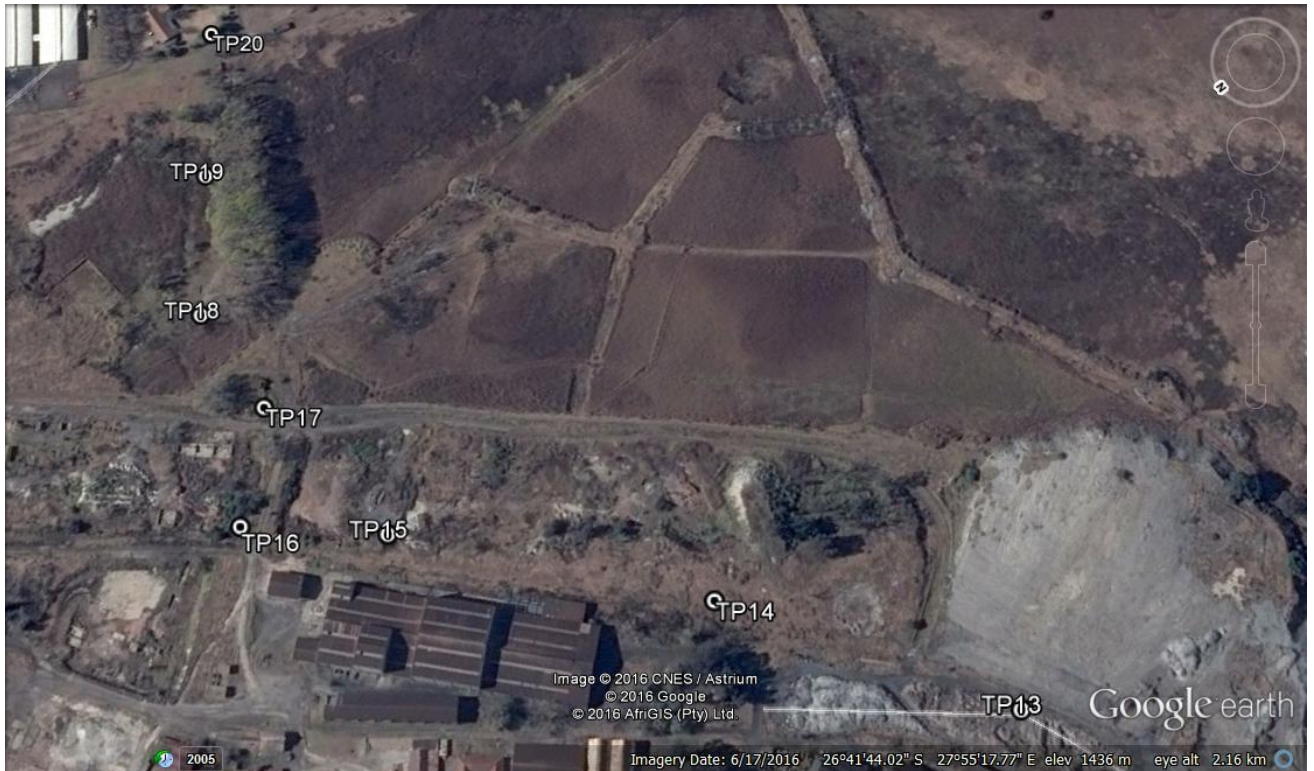
Figure 4: Water Logged Areas along the B19 Sludge Pipeline _ TP 13 to TP 20

For period on which the trenches were open, there was groundwater seepage observed within the test pits summarised within **Table 21: Groundwater Seepage within B19 Sludge Pipeline.**

The study was conducted in the month of July to August, which is a dry season and several test pits within the study only showed slightly moist conditions. Water seepage could be experienced in these test pits during rainy season.

The groundwater seepage encountered along the B19 Sludge Pipeline as well as surface runoff mean that the excavations will be flooded during construction. Dewatering of the pipe excavations shall therefore be required so that material and pipe placing can continue without disruption.

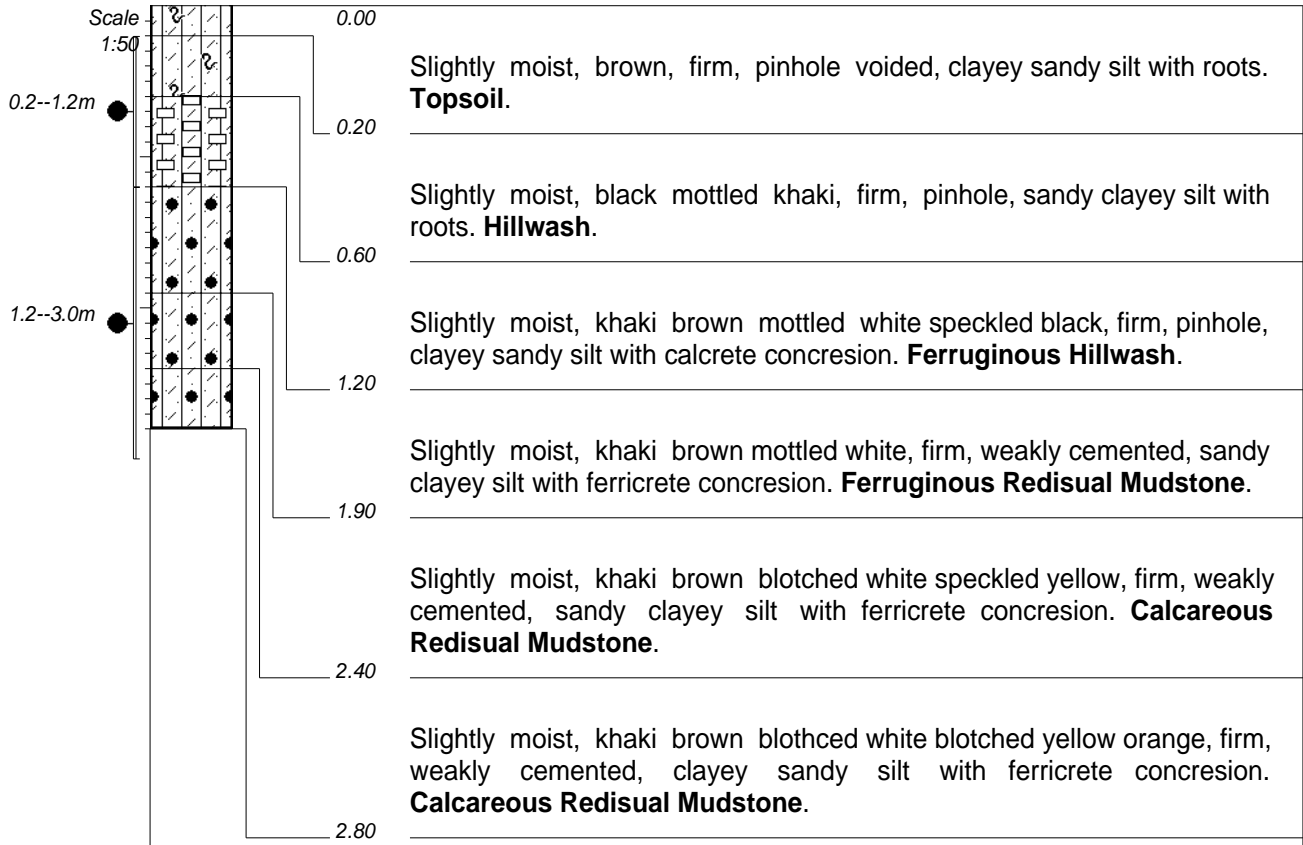
- 1) Tractor loader backhoe used for the excavations.
- 2) No groundwater seepage encountered.
- 3) Sidewalls stable.
- 4) Disturbed and bulk samples taken at 0.2--1.2m & 1.2--3.0m.
- 5) Excavated to maximum reach of the machine.

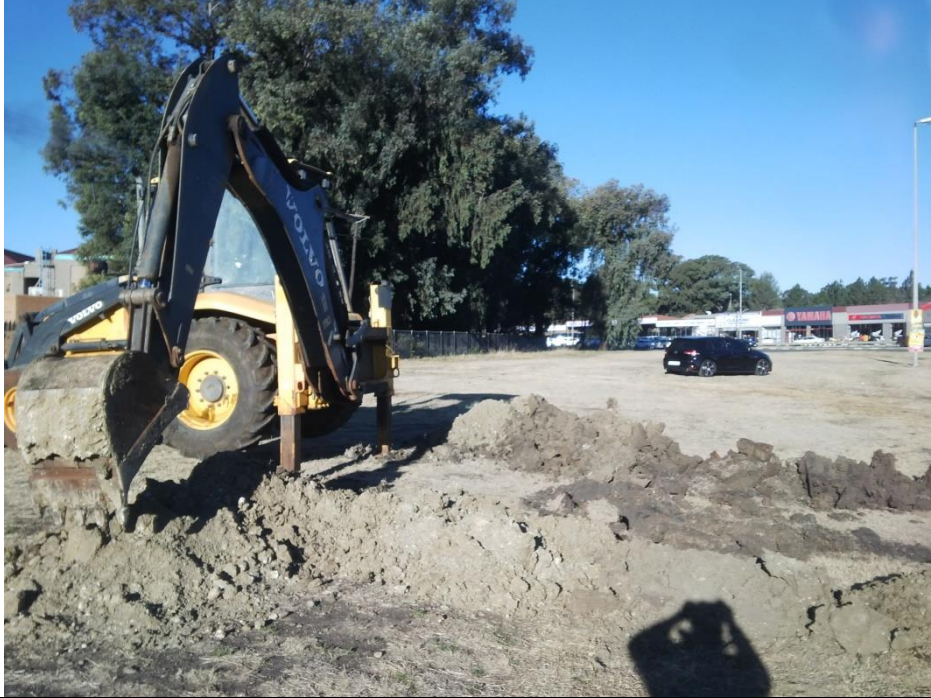
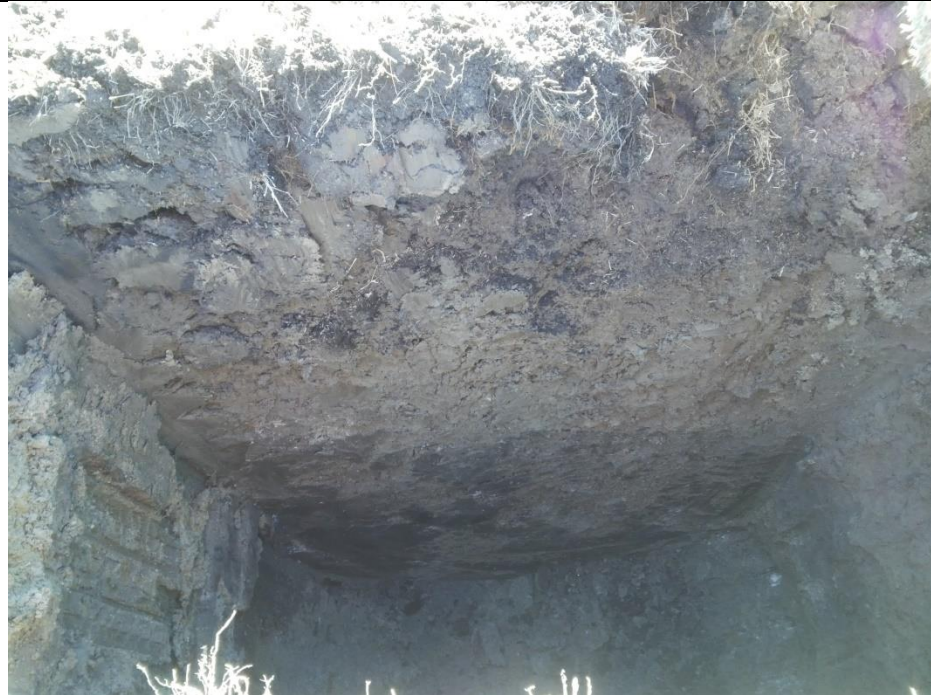
TP 1

Test Pit No. /Chainage	Soil Classification	Expected behavior	Remarks
TP1 to TP4/Ch.264 to Ch.647	CH (Inorganic clays of high plasticity)	The high plasticity clay soil has high swell potential when exposed to moisture. This could result in excessive swell pressures on the pipe base as well as sidewalls.	The clay layer below at the bottom of the trench should be excavated and replaced with inert granular material. The distance between the pipe and trench wall should also be increased beyond what the standard requires, alternatively a rigid pipe should be used.
TP4 to TP5/ Ch.647 to Ch.957	SM (Silty sands, sand-silt mixtures), SC (Clayey sands, sand-clay mixtures)	The silty sand and clayey silt soil has low swell potential.	No precautions required on the pipe foundation. Side walls to be battered to avoid soil collapse into the excavation.
TP5 to TP10/Ch.957 to Ch.1951	CH (Inorganic clays of high plasticity), CL (Inorganic clays of low to medium plasticity)	The low to high plasticity clay soil exhibits medium low to high swell potential when exposed to moisture. This could result in excessive swell pressures on the pipe base as well as sidewalls.	The clay below at the bottom of the trench should be excavated and replaced with inert granular material. The distance between the pipe and trench wall should also be increased beyond what the standard

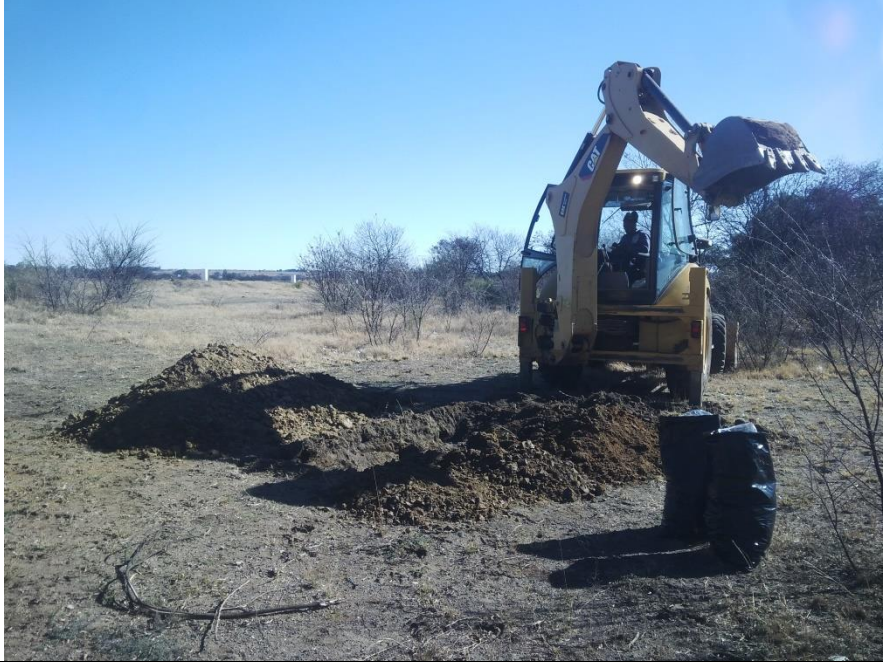
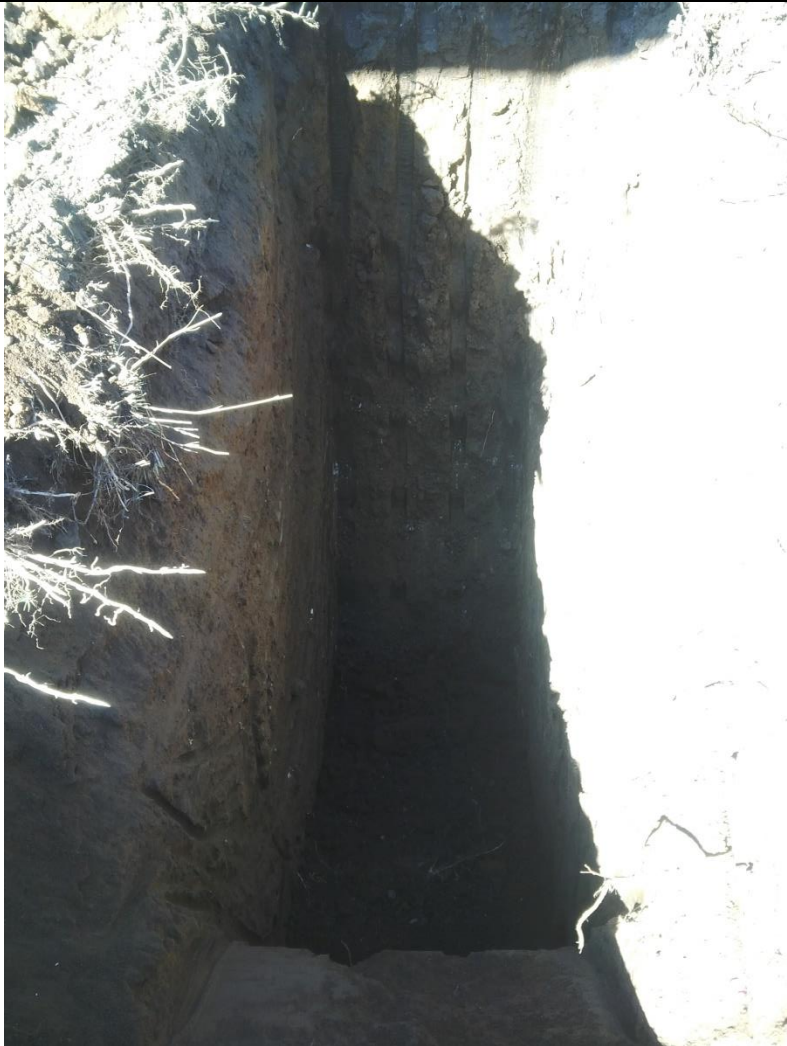
requires, alternatively a rigid pipe should be used.
TP10 to TP18/Ch.1951 to Ch.3510	SM (Silty sands, sand-silt mixtures), SC (Clayey sands, sand-clay mixtures), CL (Inorganic clays of low to medium plasticity)	The profile consists of silty sand, clayey sand and low plasticity clay. The swell potential is low to medium. Upper section between TP 13 to TP 19 consists of ASH fill. Groundwater was also encountered in this section.	The pipe foundation should be stable and only requires ripping and re-compaction before pipe bedding is placed. Dewatering of the trench will be required during excavation.
TP18 to TP28/Ch.3510 to Ch.4536	CH (Inorganic clays of high plasticity), CL (Inorganic clays of low to medium plasticity)	The medium to high plasticity clay soil exhibits medium low to high swell potential when exposed to moisture. This could result in excessive swell pressures on the pipe base as well as sidewalls. Groundwater was also encountered in this section (TP 24 to TP28).	The clayey material at the bottom of the trench should be excavated and replaced with inert granular material. The distance between the pipe and trench wall should also be increased beyond what the standard requires, alternatively a rigid pipe should be used. Dewatering of the trench will be required during excavation.
